Manningham's Healthy Waterways Program

2020 Waterwatch Health Report

**Manningham Community
Citizen Science Program**
Communities caring for catchments

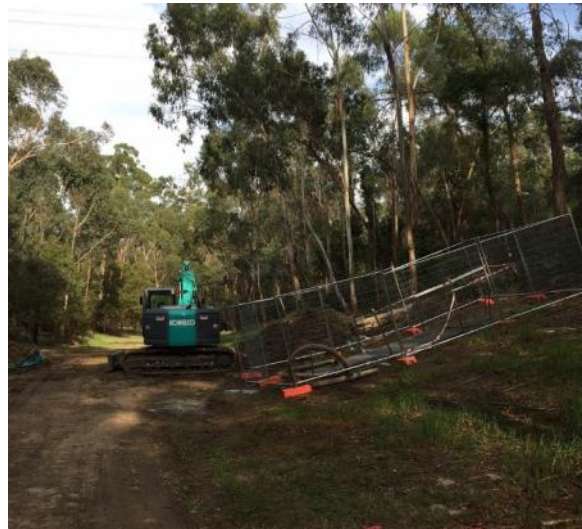
Properties connected to the new reticulated sewer

As a result a large proportion of properties are connecting to the new sewer service.

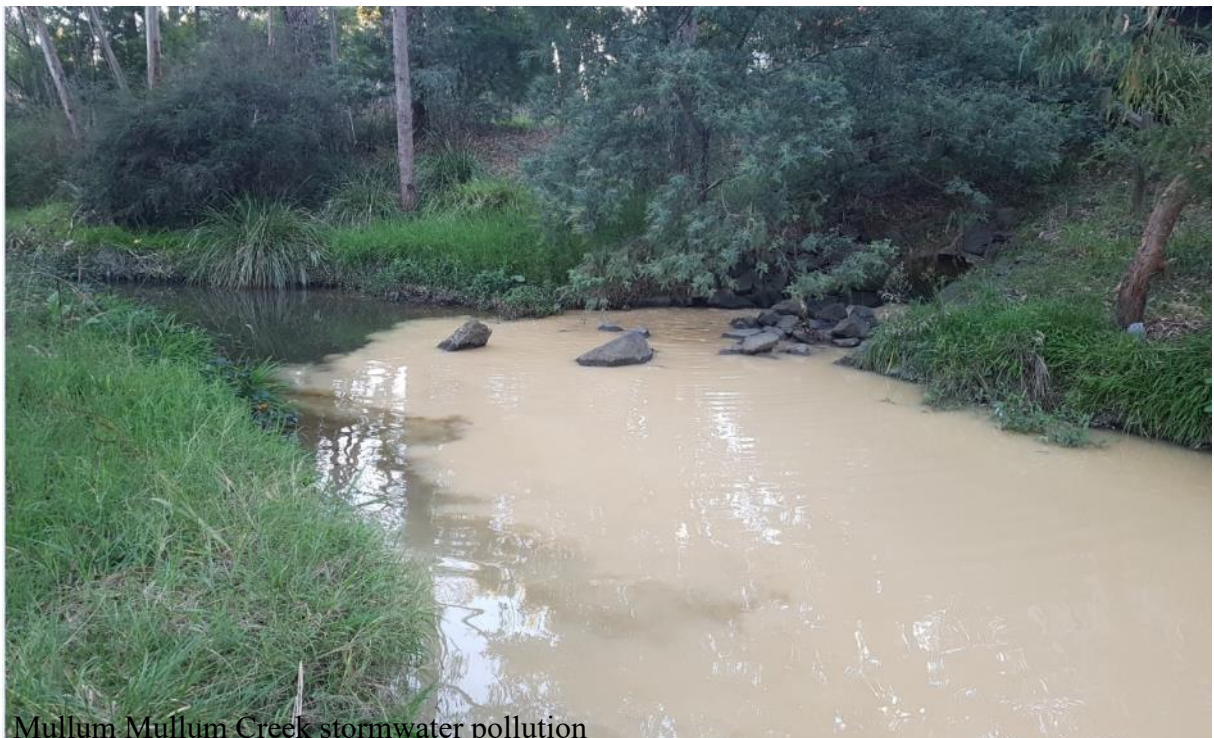
Mullum Mullum Creek stormwater pollution

Sewerage and greywater is the main source of ammonium in our waterways. In Manningham streams the presence of ammonium in high concentrations can indicate point source sewage and/or greywater pollution, particularly from stormwater drains.

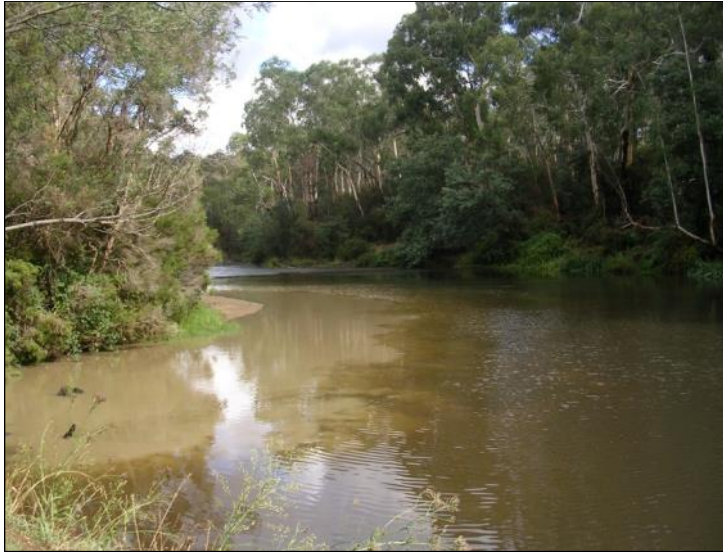
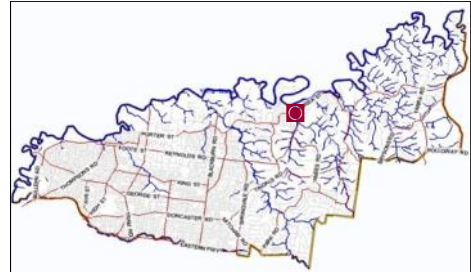
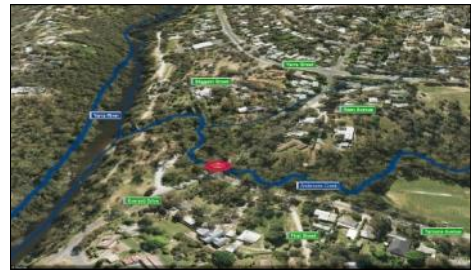
Andersons Creek @ Confluence

2019 Results	A Excellent	B Good	C Fair	D Poor	E Degraded	F Very Degraded
Overall Rating						
Ortho Phosphorus						
Electrical Conductivity						
Turbidity						
pH						
Ammonium

Water Quality Rating	2007	2008	2009	2010	2011	2012	2013	2014	2015	2016	2017	2018
Overall Rating	D-	D+	D+	D	C-	D-				C-	C-	
Nutrient Rating												
Phosphorus	F	F+	F	F	E+	E				D+	D	
Ammonium (ANZECC guideline trigger value)												
% Pass	100	100	87.5	100	100	100				100		
% Fail	0	0	12.5	0	0	0				0		
Physio/chemical Test Rating												
Turbidity	C-	E-	B-	C+	A	D				B+	A-	
Conductivity	E+	C-	D	E+	E	D-				D-	D-	
pH	B-	B	B	C	B-	B-				C	C

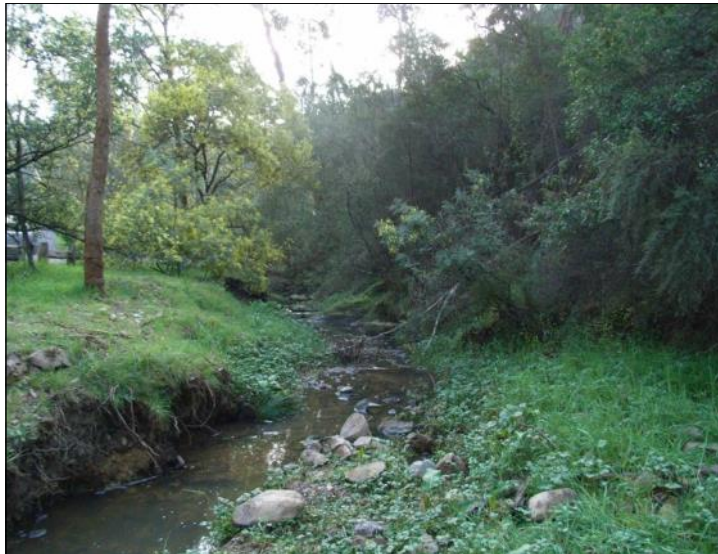
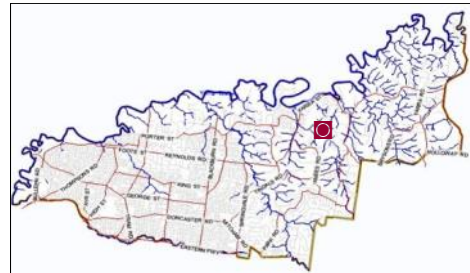
Andersons Creek @ Gold Memorial Road

2019 Results	A Excellent	B Good	C Fair	D Poor	E Degraded	F Very Degraded
Overall Rating						
Ortho Phosphorus						
Electrical Conductivity						
Turbidity						
pH						
Ammonium

Water Quality Rating	2007	2008	2009	2010	2011	2012	2013	2014	2015	2016	2017	2018
Overall Rating	E+	E+	E+	D	D-	E+	D-	D+	D+	D-	D-	E+
Nutrient Rating												
Phosphorus	F-	F-	F	F-	F-	F	F+	D-	D-	E	D-	E
Ammonium (ANZECC guideline trigger value)												
% Pass		80	75	80	90	90	75	83	41	17	25	40
% Fail		20	25	20	10	10	25	17	59	83	75	60
Physio/chemical Rating												
Turbidity	C	B	B	B	A-	C-	B-	A-	A-	B-	A	B-
Conductivity	E-	E+	E	E	E	D	E+	D-	E	E+	D-	D
pH	D	E+	E+	D-	D	E+	D	D	D	E+	D	E+

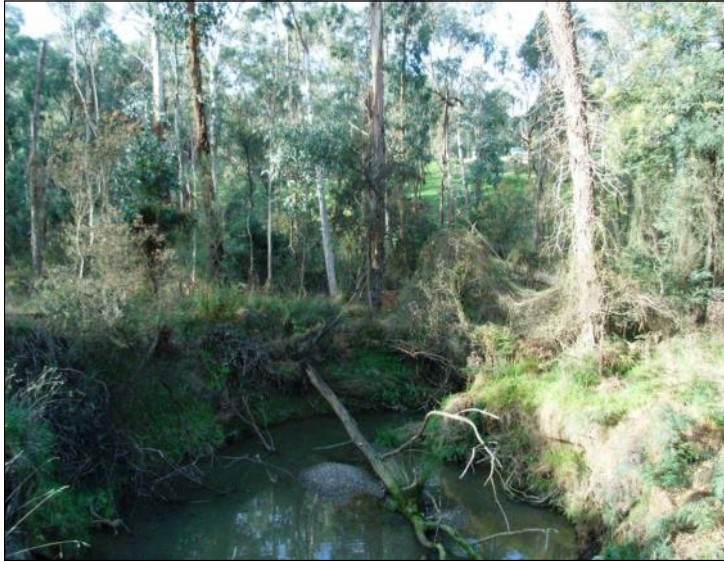
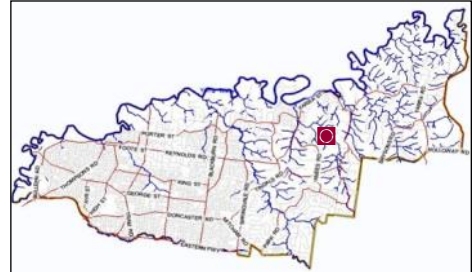
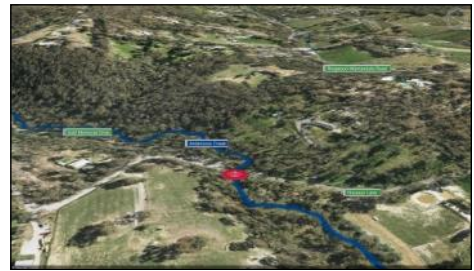
Andersons Creek @ Husseys Lane

2019 Results	A Excellent	B Good	C Fair	D Poor	E Degraded	F Very Degraded
Overall Rating						
Ortho Phosphorus						
Electrical Conductivity						
Turbidity						
pH						
Ammonium

Water Quality Rating	2007	2008	2009	2010	2011	2012	2013	2014	2015	2016	2017	2018
Overall Rating	E+	E+	E+	D-	D-	E+	D	D+	D			
Nutrient Rating												
Phosphorus	F	F-	F-	F-	F-	F-	F	D	F			
Ammonium (ANZECC guideline trigger value)												
% Pass	100	100	87.5	100	100	100	90	80	60			
% Fail	0	0	12.5	0	0	0	10	20	40			
Physio/chemical Test Rating												
Turbidity	C+	B	B	B	A-	C	B+	B	B+			
Conductivity	F+	E+	F	E	E-	E+	E	E	E+			
pH	D	E+	D-	D	D+	D	C-	D+	D-

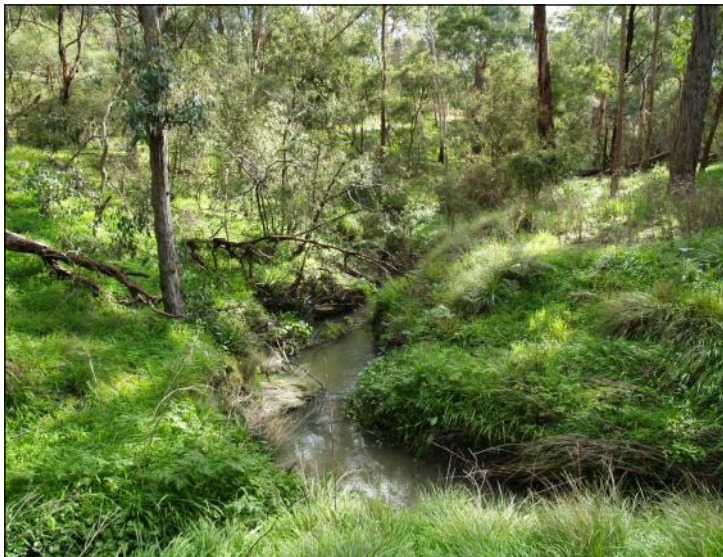
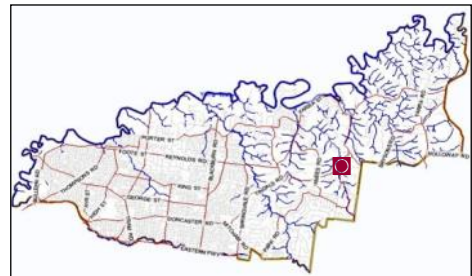
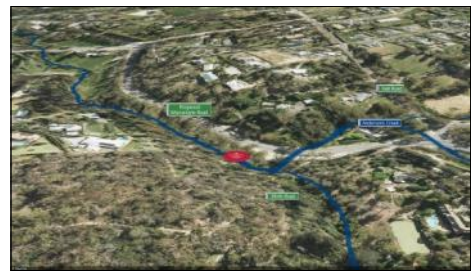
Andersons Creek @ Below Wirth Road Drain

Waterwatch monitoring done immediately downstream of the Wirth Road stormwater drain indicates that the upper section of the creek is highly impacted by contaminants found in household wastewater. Ammonium, phosphate and conductivity levels found in the upper sections of the creek are rated in the 'very degraded' range. The likely source of this pollution is the hundreds of Park Orchard properties with split greywater septic systems. These properties discharge untreated household greywater directly to stormwater.

2019 Results	A Excellent	B Good	C Fair	D Poor	E Degraded	F Very Degraded
Overall Rating	█		█		█	█
Ortho Phosphorus	█		█		█	█
Electrical Conductivity	█		█		█	█
Turbidity	█	█	█		█	█
pH	█		█		█	█
Ammonium	█		█		█	█

Water Quality Rating	2007	2008	2009	2010	2011	2012	2013	2014	2015	2016	2017	2018
Overall Rating	E	D-	D	D	D-	D-	D-		D-	D	D-	D-
Nutrient Rating												
Phosphorus	F-	F-	F-	F-	F-	F-	F-		F-	E+	E+	F
Ammonium (ANZECC guideline trigger value)												
% Pass	100	100	87.5	100	100	100	90		100	100		25
% Fail	0	0	12.5	0	0	0	10		0	0		75
Physio/chemical Rating												
Turbidity	A-	B	B	B	A+	A+	A+		A+	A+	A+	A
Conductivity	F	E-	E	E	F	F-	F-		F-	F	F	F
pH	B	B-	B	C+	C+	B-	B		B	C-	C+	B-

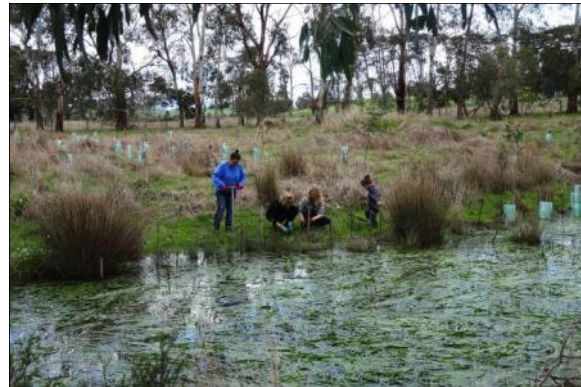
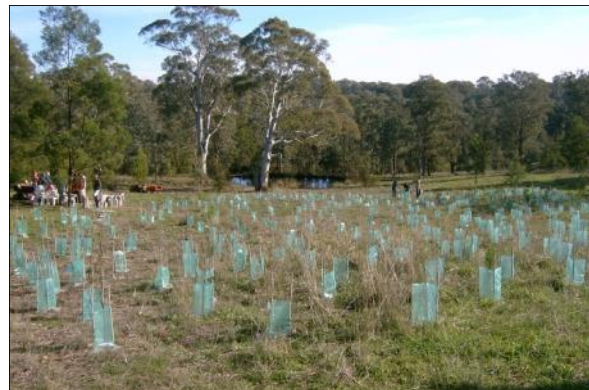
Brushy Creek Ortho-phosphorus Levels in Wonga Park

The construction of the new Wonga Park sewerage service was completed in 2012. By the end of 2015 most properties were connected to the new sewer.

The results indicate that there was a significant reduction in ortho phosphate, electrical conductivity and ammonium in Brushy Creek after the completion and connection of local residents to the new sewer service.

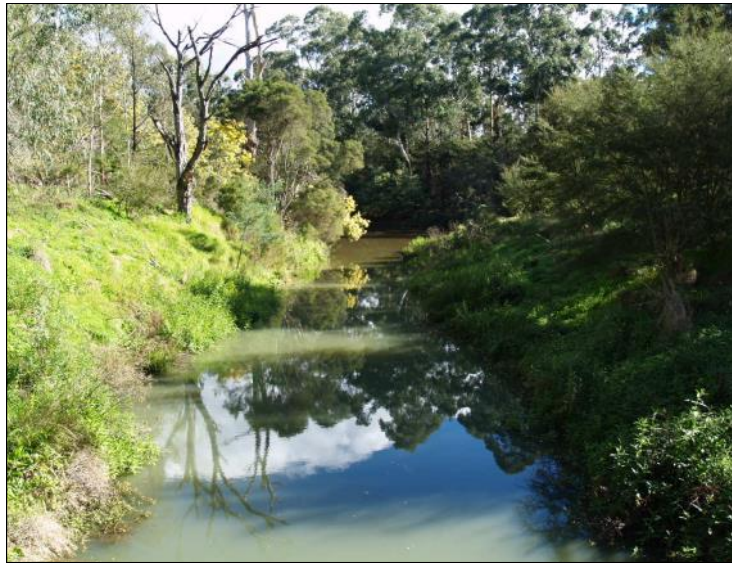
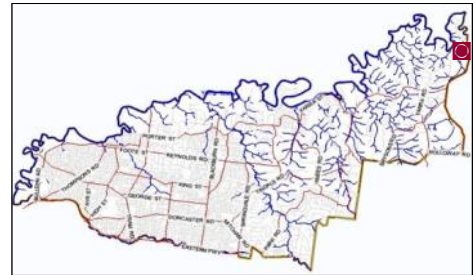
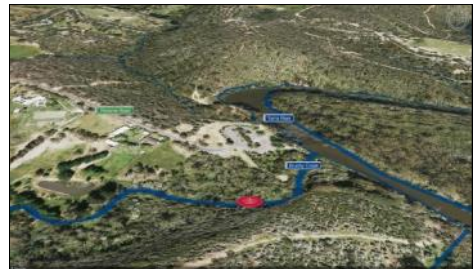
Brushy Creek — Confluence of Yarra River

2017 Results	A Excellent	B Good	C Fair	D Poor	E Degraded	F Very Degraded
Overall Rating			💧			
Ortho Phosphorus				💧		
Electrical Conductivity				💧		
Turbidity	💧					
pH		💧				
Ammonium	💧

Water Quality Rating	2007	2008	2009	2010	2011	2012	2013	2014	2015	2016	2017	2018
Overall Rating	D-	D+		C			D+	E+	C	C	C+	
Nutrient Rating												
Phosphorus	F	F-		E			C-	F	C-	D+	D+	
Ammonium (ANZECC guideline trigger value)												
% Pass							100	100	78	100	100	
% Fail							0	0	22	0	0	
Physio/chemical Rating												
Turbidity	D-	B		A+			E	F-	C	D+	A	
Conductivity	D	D		D			D+	D+	D	D+	D	
pH	B	B		B			B	B	B	B	B

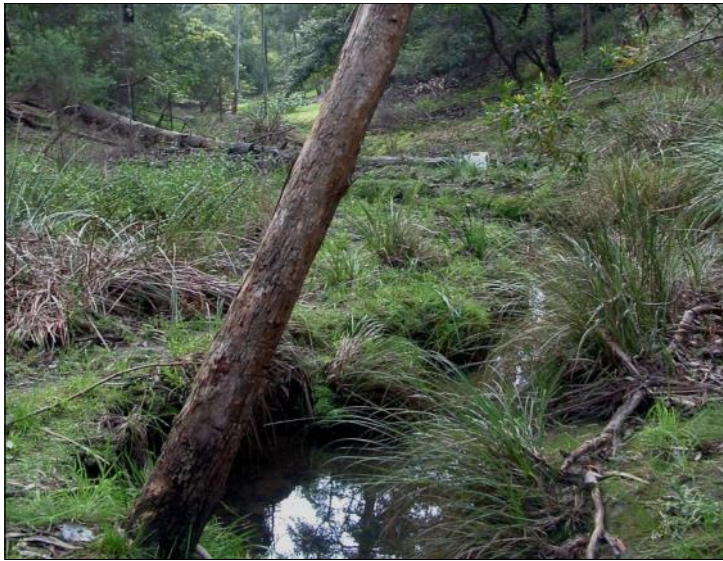
Jumping Creek @ Merrill Crescent

2019 Results	A Excellent	B Good	C Fair	D Poor	E Degraded	F Very Degraded
Overall Rating			💧			
Ortho Phosphorus			💧			
Electrical Conductivity					💧	
Turbidity	💧					
pH			💧			
Ammonium			💧

Water Quality Rating	2007	2008	2009	2010	2011	2012	2013	2014	2015	2016	2017	2018
Overall Rating	C+	C	C+	C+	C	C	C	C-	C	C	C	C
Nutrient Rating												
Phosphorus	B-	B-	B-	C	D	D	D+	C-	C-	C	C	C
Ammonium (ANZECC guideline trigger value)												
% Pass		100	80	91	64	55	78	62	75	62	90	90
% Fail		0	20	9	36	45	22	38	25	38	10	10
Physio/chemical Test Rating												
Turbidity	B+	B+	A+	B+	A+	A	A	A+	A	B	A+	A
Conductivity	E+	E-	D	D-	E-	E	E	F	E+	D	E+	E
pH	B-	C+	C+	B-	B	B-	B	C+	B	C	C	C

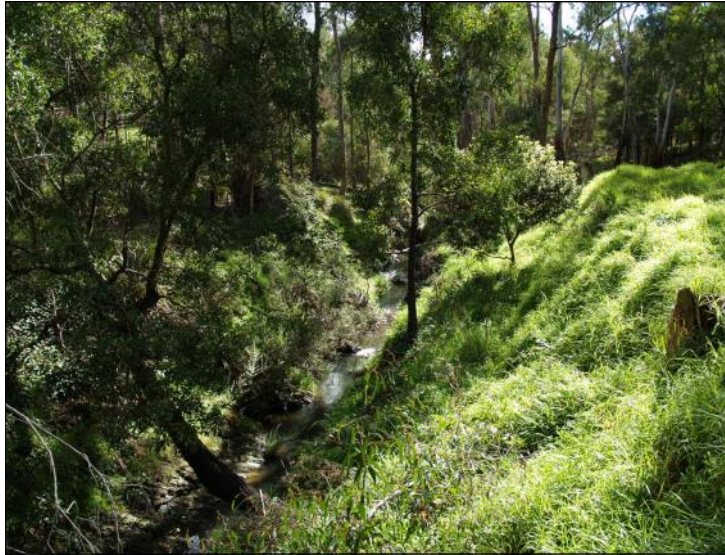
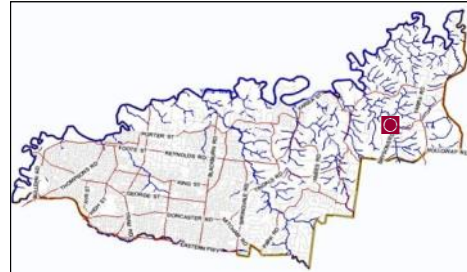
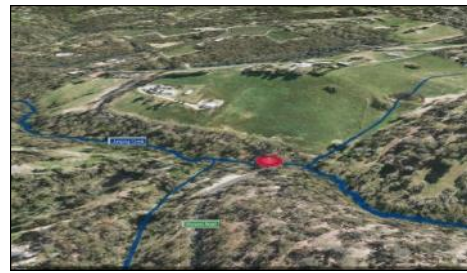
Jumping Creek @ Brysons Road

2017 Results	A Excellent	B Good	C Fair	D Poor	E Degraded	F Very Degraded
Overall Rating			💧			
Ortho Phosphorus			💧			
Electrical Conductivity				💧		
Turbidity		💧				
pH		💧				
Ammonium			💧

Water Quality Rating	2007	2008	2009	2010	2011	2012	2013	2014	2015	2016	2017	2018
Overall Rating	C-	C	C	C	C-	C-	C-			C	C	
Nutrient Rating												
Phosphorus	A+	C+	D	D	C-	B-	C-			B	B	
Ammonium (ANZECC guideline trigger value)												
% Pass		100	67	100	100	100	100			100	100	
% Fail		0	33	0	0	0	0			0	0	
Physio/chemical Test Rating												
Turbidity	C+	A	A+	A-	A+	A+	B			A+	B	
Conductivity	E	E+	E	D-	E-	F	F+			D	D	
pH		C	B-	B	D-	D+	C			B	B

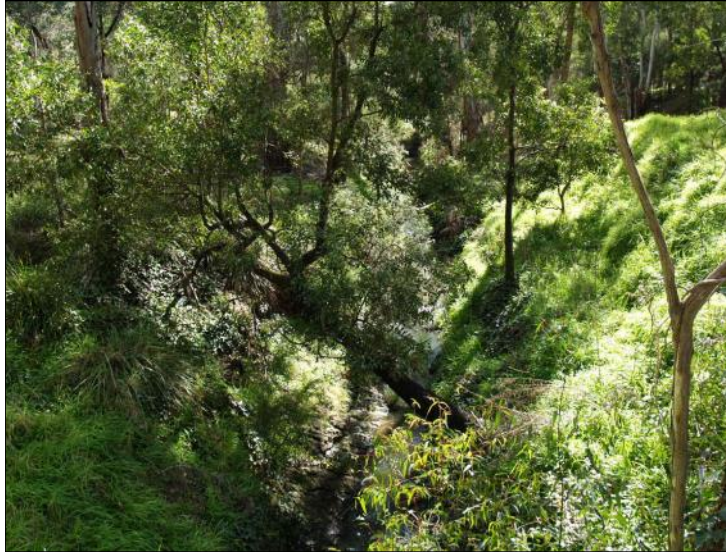
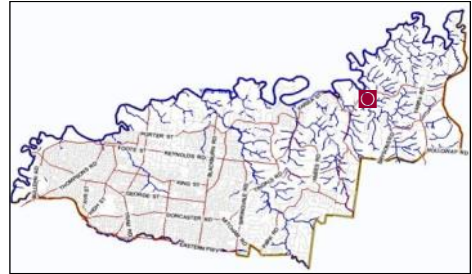
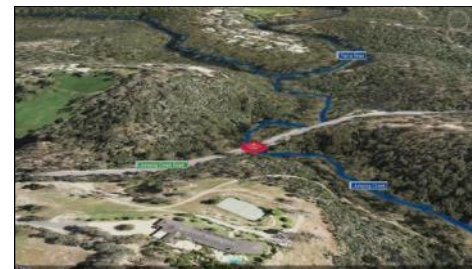
Jumping Creek — Confluence of Yarra River

2016 Results	A Excellent	B Good	C Fair	D Poor	E Degraded	F Very Degraded
Overall Rating						
Ortho Phosphorus						
Electrical Conductivity						
Turbidity						
pH						
Ammonium

Water Quality Rating	2007	2008	2009	2010	2011	2012	2013	2014	2015	2016	2017	2018
Overall Rating	C-	C-		C	C-						C+	
Nutrient Rating												
Phosphorus	D	C+		D-	A-						A	
Ammonium (ANZECC guideline trigger value)												
% Pass				100	100						100	
% Fail				0	0						0	
Physio/chemical Rating												
Turbidity	C	A-		B+	A+						A+	
Conductivity	E	D-		D+	E						D	
pH	B	C		B	D						B

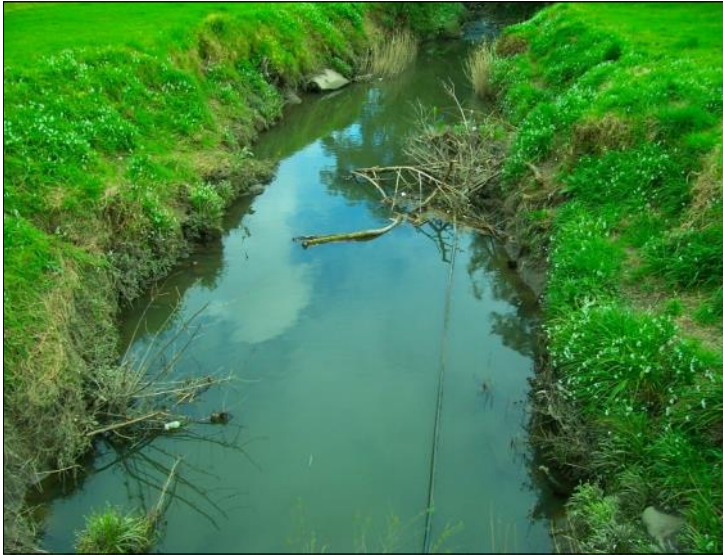
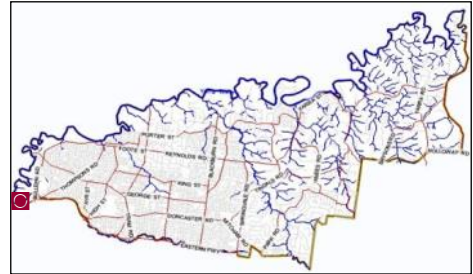
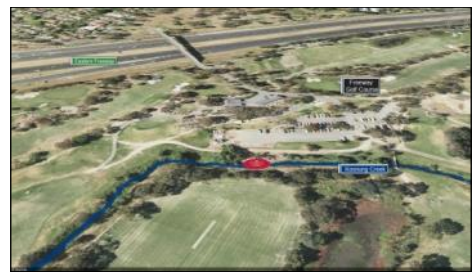
Koonung Creek @ Freeway Golf Course

2019 Results	A Excellent	B Good	C Fair	D Poor	E Degraded	F Very Degraded
Overall Rating						
Ortho Phosphorus						
Electrical Conductivity						
Turbidity						
pH						
Ammonium

Water Quality Rating	2007	2008	2009	2010	2011	2012	2013	2014	2015	2016	2017	2018
Overall Rating				C+	C	C	C+	C	C+	C-	D+	D
Nutrient Rating												
Phosphorus				C+	D+	C	B	C-	C-	D+	D	D-
Ammonium (ANZECC guideline trigger value)												
% Pass				82	27	50	100	36	58	36	36	36
% Fail				18	73	50	0	64	42	64	64	64
Physio/chemical Rating												
Turbidity				B	B	B	B+	B+	B+	B	C-	D
Conductivity				D-	E+	E+	C+	D-	D+	D+	D+	D-
pH				B	B-	B-	D	C+	B	B	B	B

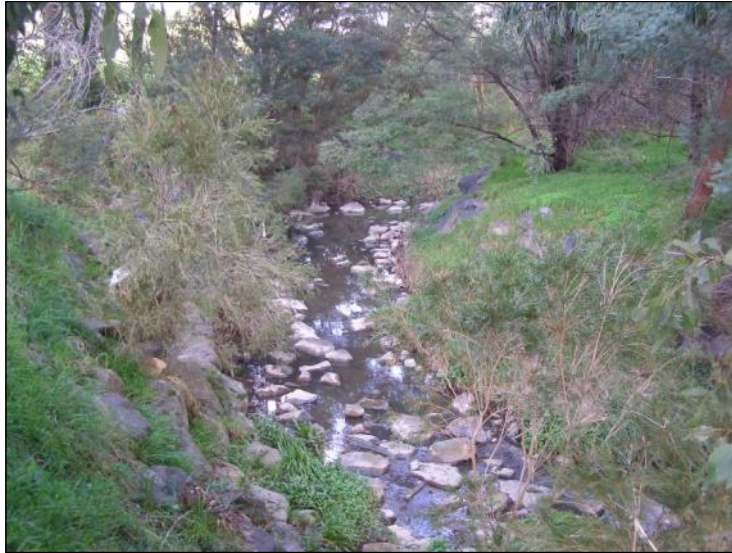
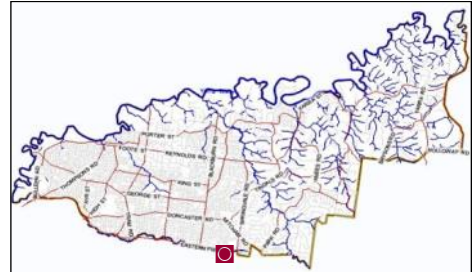
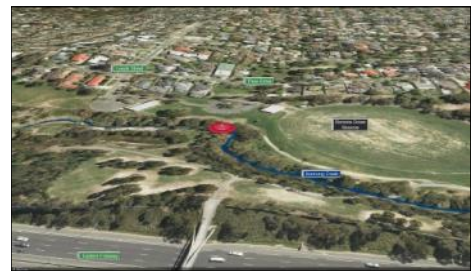
Koonung Creek @ Leeds Street

2019 Results	A Excellent	B Good	C Fair	D Poor	E Degraded	F Very Degraded
Overall Rating						
Ortho Phosphorus						
Electrical Conductivity						
Turbidity						
pH						
Ammonium

Water Quality Rating	2007	2008	2009	2010	2011	2012	2013	2014	2015	2016	2017	2018
Overall Rating			C+	C+	C	C	C-	C	C	C-	C	C
Nutrient Rating												
Phosphorus			C	C	D+	B	C+	B-	C-	C	B-	C
Ammonium (ANZECC guideline trigger value)												
% Pass			67	89	100	100	87	90	45	90	40	60
% Fail			33	11	0	0	13	10	55	10	60	40
Physio/chemical Rating												
Turbidity			A+	A+	A+	B-	B-	A+	A+	A+	A-	A+
Conductivity			D-	E	E-	F+	E	E	E	E+	E	E-
pH			C	B-	B	C+	C	C	B	B	B	B

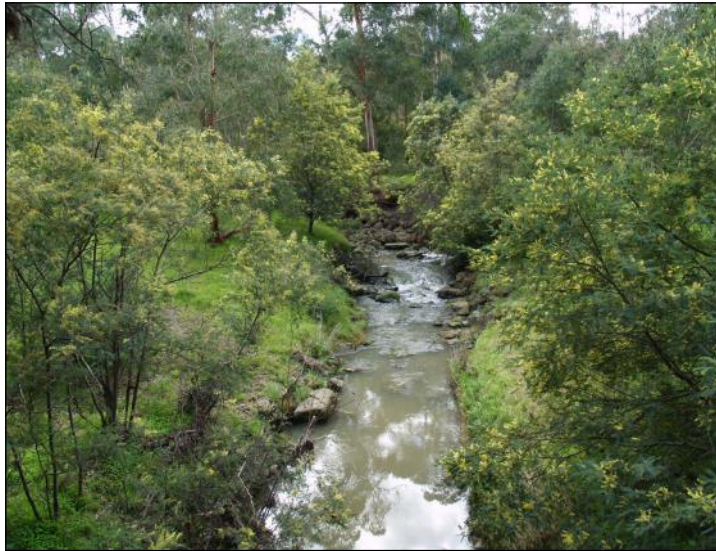
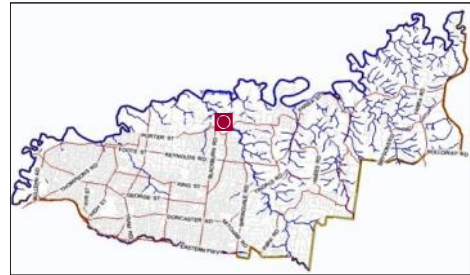
Mullum Mullum Creek @ The Parkway

2019 Results	A Excellent	B Good	C Fair	D Poor	E Degraded	F Very Degraded	
Overall Rating			💧				
Ortho Phosphorus				💧			
Electrical Conductivity			💧				
Turbidity			💧				
pH		💧					
Ammonium		💧

Water Quality Rating	2007	2008	2009	2010	2011	2012	2013	2014	2015	2016	2017	2018
Overall Rating	E	D	C-	C-	D+	C-	C-	C	C-	C	B+	C
Nutrient Rating												
Phosphorus	F-	E-	E	E	F+	E	E-	F+	F	E-	D	E
Ammonium (ANZECC guideline trigger value)												
% Pass			100	92	75	100	100	100	100	75	100	100
% Fail			0	8	25	0	0	0	0	25	0	0
Physio/chemical Test Rating												
Turbidity	D	D-	B-	C	B-	A+	A+	B-	A+	A+	C	C
Conductivity	F-	C	D+	C-	E-	D-	D-	C+	D	D-	C-	C
pH	B	C+	C+	B-	B	B	C+	B	B	D+	B	B

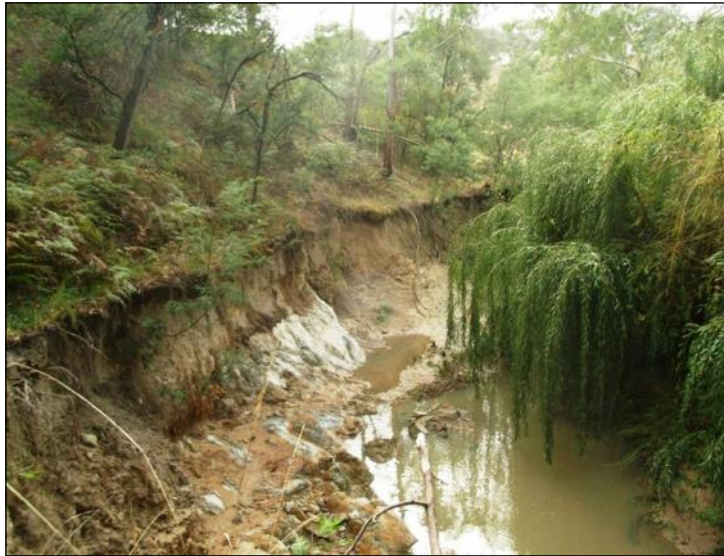
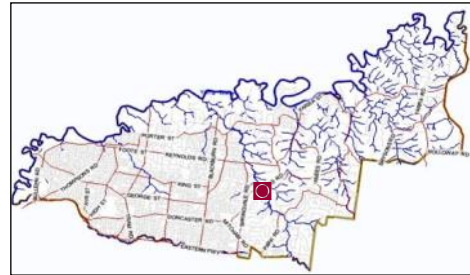
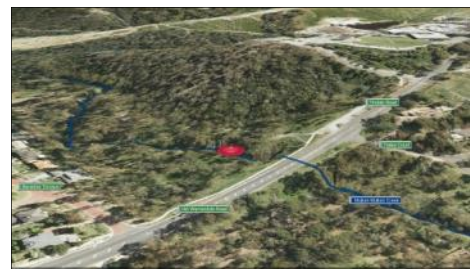
Mullum Mullum Creek @ Tindals Road

2019 Results	A Excellent	B Good	C Fair	D Poor	E Degraded	F Very Degraded
Overall Rating						
Ortho Phosphorus						
Electrical Conductivity						
Turbidity						
pH						
Ammonium

Water Quality Rating	2007	2008	2009	2010	2011	2012	2013	2014	2015	2016	2017	2018
Overall Rating	D+	D+	D+	D+	D+	D+	C-	C-	C-	C-	D+	D
Nutrient Rating												
Phosphorus	F-	F-	F-	F	F-	F	F+	F	F	F-	E	E
Ammonium (ANZECC guideline trigger value)												
% Pass			60	12	83	72	20	25	80	70	50	20
% Fail			40	78	17	28	80	75	20	30	50	80
Physio/chemical Rating												
Turbidity	C	B+	A	B+	A+	A-	A	A	B+	A+	A+	A
Conductivity	D	D+	D	D+	D-	E+	D	D-	D-	D	D	D-
pH	B	B	C+	B-	B-	B	B	B	B+	C	C	C

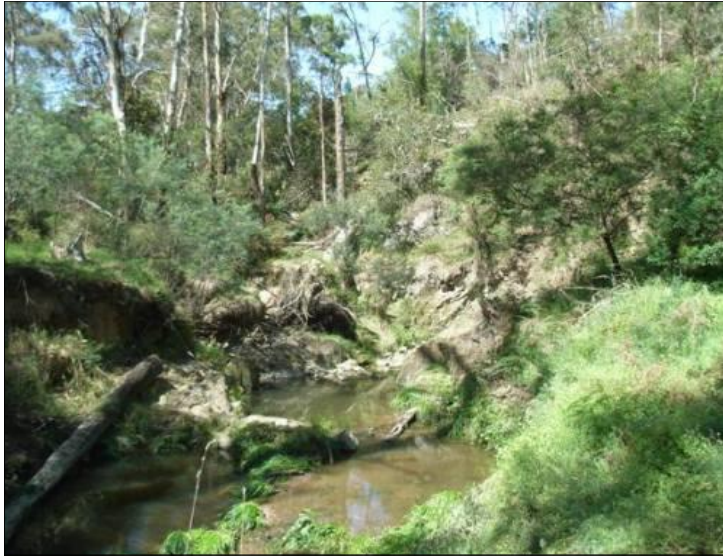
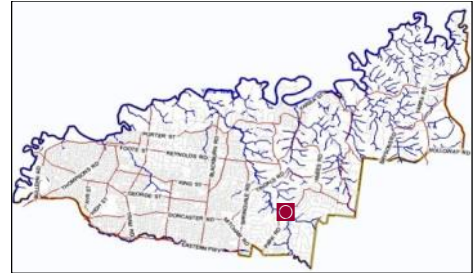
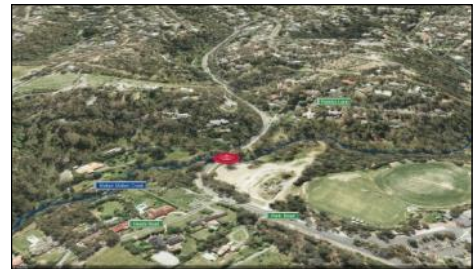
Mullum Mullum Creek @ Park Road

2019 Results	A Excellent	B Good	C Fair	D Poor	E Degraded	F Very Degraded
Overall Rating						
Ortho Phosphorus						
Electrical Conductivity						
Turbidity						
pH						
Ammonium

Water Quality Rating	2007	2008	2009	2010	2011	2012	2013	2014	2015	2016	2017	2018
Overall Rating	D+	D+	F+	F-	F	D	C	C-	D	D	D	E
Nutrient Rating												
Phosphorus	F	F	F+	F-	F-	F-	F-	F-	E-	E-	E-	E-
Ammonium (ANZECC guideline trigger value)												
% Pass	33	20	33	80	25		67	50	0	70	67	70
% Fail	67	80	67	20	75		33	50	100	30	33	30
Physio/chemical Test Rating												
Turbidity	B	B	A+	A+	A+	A+	A+	A+	A+	A+	A+	A+
Conductivity	D+	D+	E+	D	D-	D	C-	C	D	C-	C-	D+
pH	B	C+	C+	C+	C+	D	B-	B	C	C	C	C+

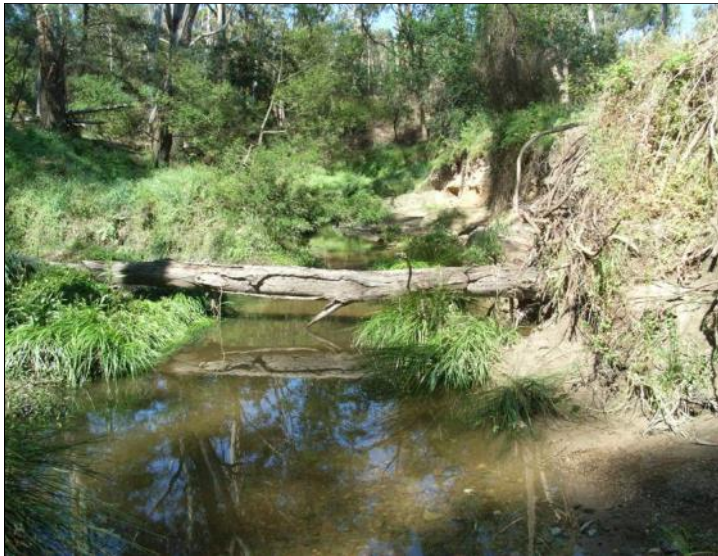
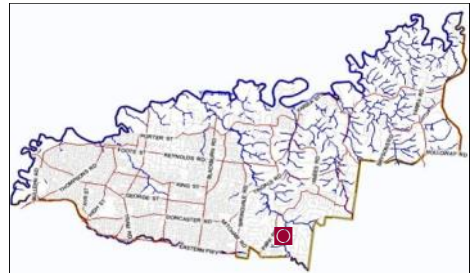
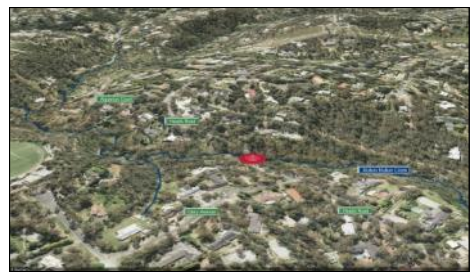
Mullum Mullum Creek @ Heads Road

2019 Results	A Excellent	B Good	C Fair	D Poor	E Degraded	F Very Degraded
Overall Rating						
Ortho Phosphorus						
Electrical Conductivity						
Turbidity						
pH						
Ammonium

Water Quality Rating	2007	2008	2009	2010	2011	2012	2013	2014	2015	2016	2017	2018
Overall Rating	D+	C-	C-	C+	C+	B-	C-	C	C	C	C	C
Nutrient Rating												
Phosphorus	F	E-	E	E+	D	D	D	D	D	D	D	D
Ammonium (ANZECC guideline trigger value)												
% Pass	67	80	67	80	67				70		70	70
% Fail	33	20	33	20	33				30		30	30
Physio/chemical Rating												
Turbidity	A+	B	A+	A+	A+	A+	A+	A+	A+	A+	A+	A+
Conductivity	C-	C-	D	D	D+	C	D	C	C	C	C	C
pH		C+	C	B-	B-	B	C	C	C	C	C+	C+

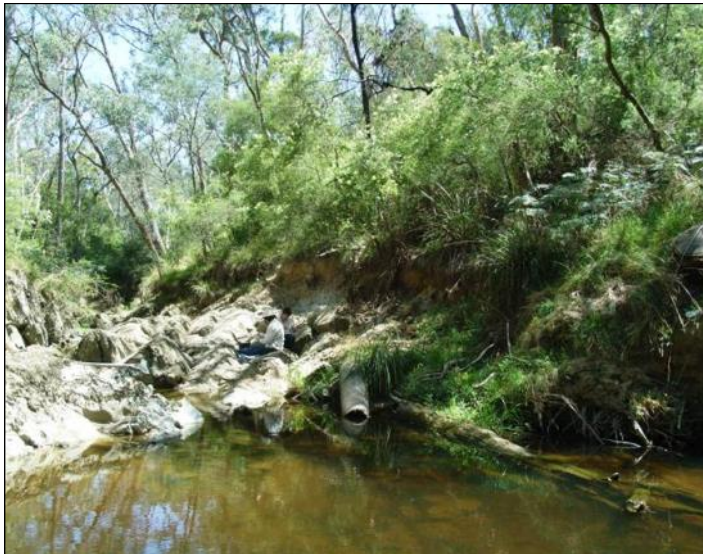
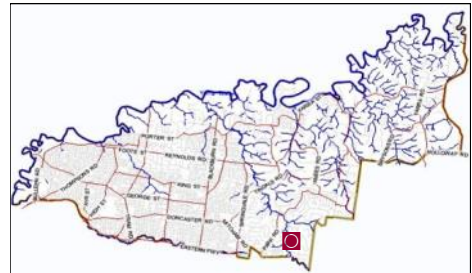
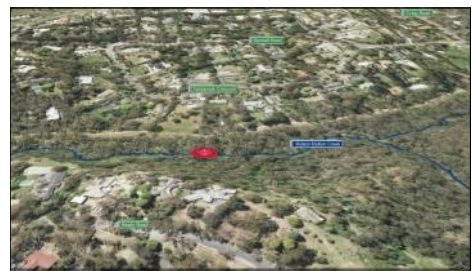
Mullum Mullum Creek @ Tandarook Crescent

2019 Results	A Excellent	B Good	C Fair	D Poor	E Degraded	F Very Degraded
Overall Rating	[Progress bar showing 2 segments in A, 1 segment in B, and 3 segments in C]					
Ortho Phosphorus	[Progress bar showing 2 segments in A, 1 segment in B, and 3 segments in C]					
Electrical Conductivity	[Progress bar showing 2 segments in A, 1 segment in B, and 3 segments in C]					
Turbidity	[Progress bar showing 1 segment in A, 1 segment in B, and 4 segments in C]					
pH	[Progress bar showing 2 segments in A, 1 segment in B, and 3 segments in C]					
Ammonium	[Progress bar showing 2 segments in A, 1 segment in B, and 3 segments in C]

Water Quality Rating	2007	2008	2009	2010	2011	2012	2013	2014	2015	2016	2017	2018
Overall Rating	C-	D+	C+	C+	C+	C+	C	C+	C+	C	C+	C
Nutrient Rating												
Phosphorus	F-	E-	F	E-	F	D-	D	D	C+	C+	C+	C+
Ammonium (ANZECC guideline trigger value)												
% Pass		100	67	100	67		67		100	100	90	90
% Fail		0	33	0	33		33		0	0	10	10
Physio/chemical Test Rating												
Turbidity	A+	B-	A+	B-	A+	A+	A+	A+	A+	A-	A+	A+
Conductivity	C	C	D-	C	D-	D+	C	D+	C-	C	C+	C
pH		C+	C+	C+	C+	B-	C	B-	B-	C+	B	C

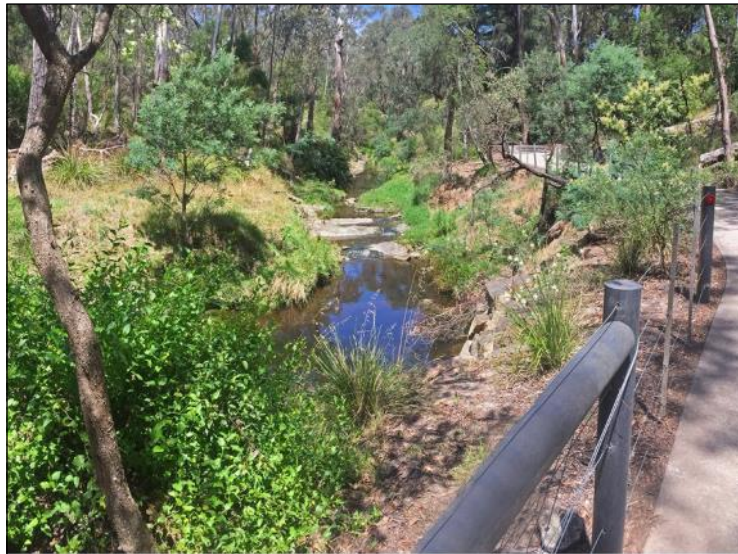
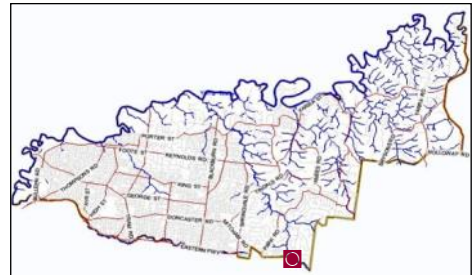
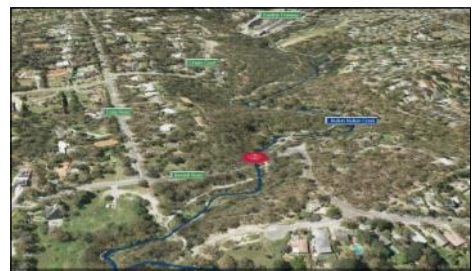
Mullum Mullum Creek @ Quarry Road

2019 Results	A Excellent	B Good	C Fair	D Poor	E Degraded	F Very Degraded	
Overall Rating	█		█				
Ortho Phosphorus	█		█				
Electrical Conductivity	█		█				
Turbidity	█	█					
pH	█		█				
Ammonium	█		█

Water Quality Rating	2007	2008	2009	2010	2011	2012	2013	2014	2015	2016	2017	2018
Overall Rating	C+	C+	C	B-	B-	B-	C+	B-	B	B	B-	B-
Nutrient Rating												
Phosphorus	C+	C	D	B+	C	B-	C	C-	A+	B	B-	B-
Ammonium (ANZECC guideline trigger value)												
% Pass	100	100	67	100	100	100	100	100	100	100	90	100
% Fail	0	0	33	0	0	0	0	0	0	0	10	0
Physio/chemical Rating												
Turbidity	B	B	B	A+	A+	A+	B	A+	A+	B+	A+	B
Conductivity	C-	C	D	C-	C-	C	C+	C	B-	C	C+	C+
pH	B	C	C+	C	C+	D	C+	B-	C-	C	B-	C

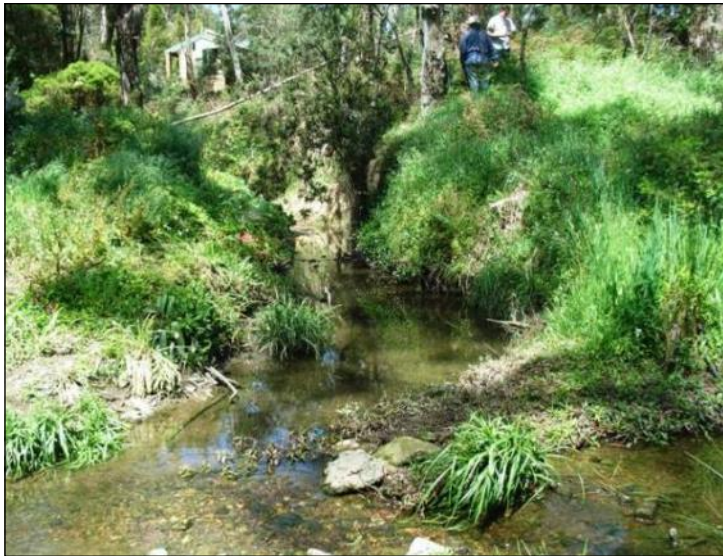
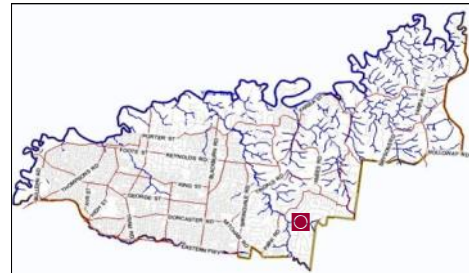
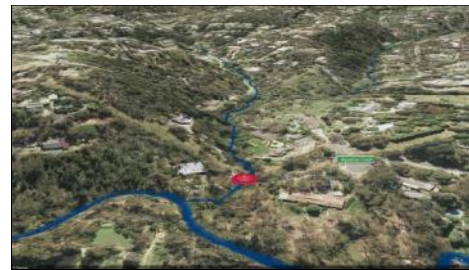
Mullum Mullum Creek @ Paddy's Lane Tributary

2019 Results	A Excellent	B Good	C Fair	D Poor	E Degraded	F Very Degraded	
Overall Rating							
Ortho Phosphorus							
Electrical Conductivity							
Turbidity							
pH							
Ammonium

Water Quality Rating	2007	2008	2009	2010	2011	2012	2013	2014	2015	2016	2017	2018
Overall Rating	E	E	D	D	E	E	E	E	E	E	F	F
Nutrient Rating												
Phosphorus	F-	F-	F-	F-	F-	F-	F-	F-	F-	F-	F-	F-
Ammonium (ANZECC guideline trigger value)												
% Pass	0	0	0	0	0	0	0	0	0	0	0	0
% Fail	100	100	100	100	100	100	100	100	100	100	100	100
Physio/chemical Test Rating												
Turbidity	A	A+	A+	A+	B	A+	A+	A+	A+	A+	A+	B
Conductivity	F	F+	F+	F+	F	F-	F-	F-	F-	F-	F-	F-
pH	B	B	B	B	B	B	B	B	B	B	B	B

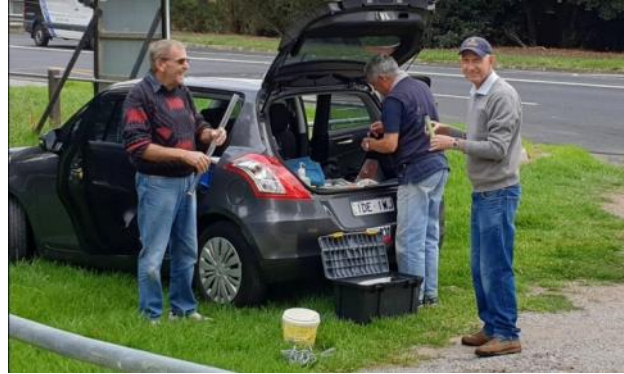
Since 2012 and the construction of the new sewer service to Templestowe, Ruffey Creek has been transformed from a severely polluted creek into a relatively healthy urban waterway.

Top: Waterwatch data highlights the dramatic drop in Ortho-Phosphate in Ruffey Creek in 2012 and the completion of the Yarra Valley Water Sewer service.

To coincide with the declaration of the new sewer service Waterwatch hosted a community picnic in Templestowe in collaboration with Yarra valley Water, Manningham Council and local plumbers. As a result of this community engagement there was a 95% uptake by local residents to the new sewer service. This led to a dramatic improvement to water quality of the creek.

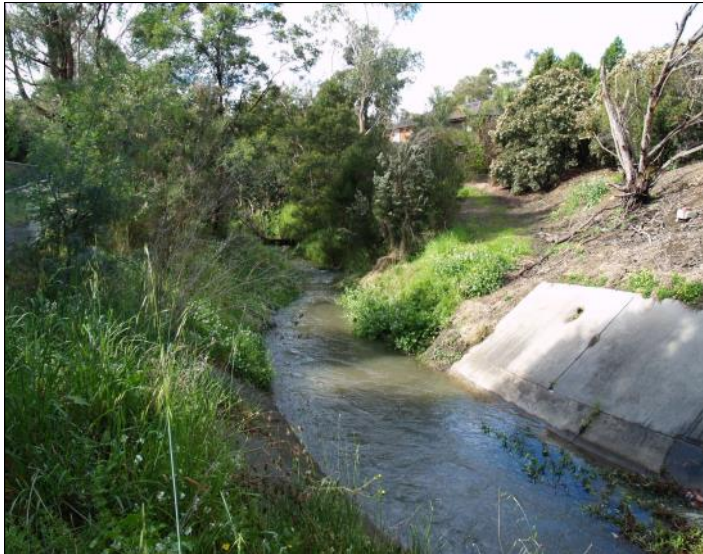
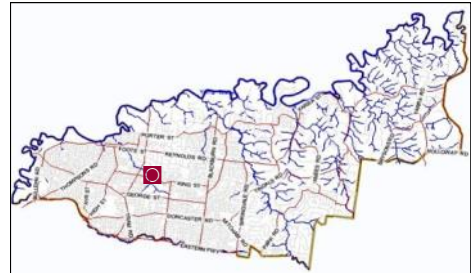
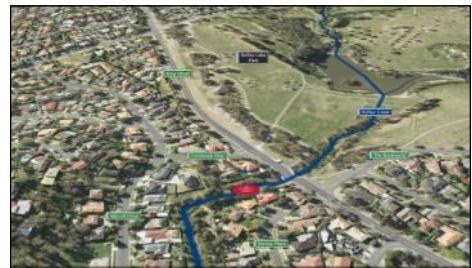
Ruffey Creek @ King Street

2019 Results	A Excellent	B Good	C Fair	D Poor	E Degraded	F Very Degraded
Overall Rating						
Ortho Phosphorus						
Electrical Conductivity						
Turbidity						
pH						
Ammonium

Water Quality Rating	2007	2008	2009	2010	2011	2012	2013	2014	2015	2016	2017	2018
Overall Rating		C	C+	C	C	C-	C	C	C+	C	C-	C
Nutrient Rating												
Phosphorus		C	C-	D+	D	C-	D+	C-	C+	B	B-	B-
Ammonium (ANZECC guideline trigger value)												
% Pass		40	30	20	20	87.5	62	40	89	90	40	40
% Fail		60	70	80	80	12.5	38	60	11	10	60	60
Physio/chemical Test Rating												
Turbidity		A+	A	B-	A-	B-	B-	A	A+	B	A	A
Conductivity		F+	D	D-	E+	F	D-	D-	E	E+	E	D-
pH		B	C+	B	C+	B-	B-	B-	B-	B-	C+	C

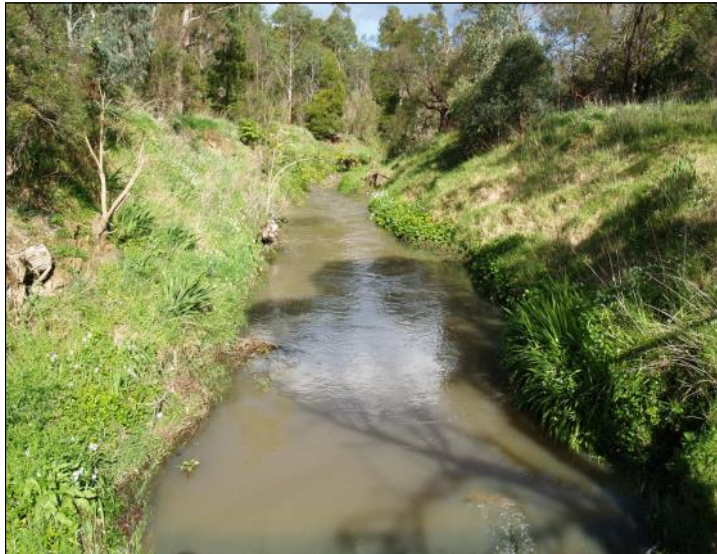
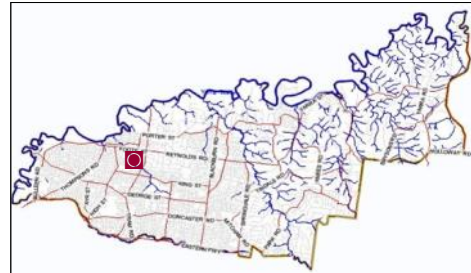
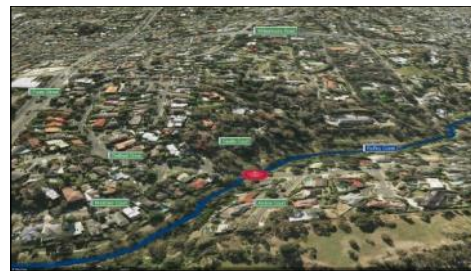
Ruffey Creek @ Dellfield Drive

2019 Results	A Excellent	B Good	C Fair	D Poor	E Degraded	F Very Degraded
Overall Rating			💧			
Ortho Phosphorus			💧			
Electrical Conductivity						💧
Turbidity	💧					
pH		💧				
Ammonium	💧

Water Quality Rating	2007	2008	2009	2010	2011	2012	2013	2014	2015	2016	2017	2018
Overall Rating		D+	C-	C-	D+	D+	C-	C	C	C-	C+	C
Nutrient Rating												
Phosphorus		E-	F+	E+	F	D-	C-	C	C+	B-	B-	B-
Ammonium (ANZECC guideline trigger value)												
% Pass		80	50	62.5	100	86	75	70	80	60	100	80
% Fail		20	50	37.5	0	14	25	30	20	40	0	20
Physio/chemical Test Rating												
Turbidity		A+	A-	A-	A+	A-	B	A+	A-	B+	A-	A
Conductivity		F	D-	D-	E-	F-	E-	E	E-	D-	F+	E
pH		C+	B-	B-	C+	B-	B-	C+	B-	B-	B+	B

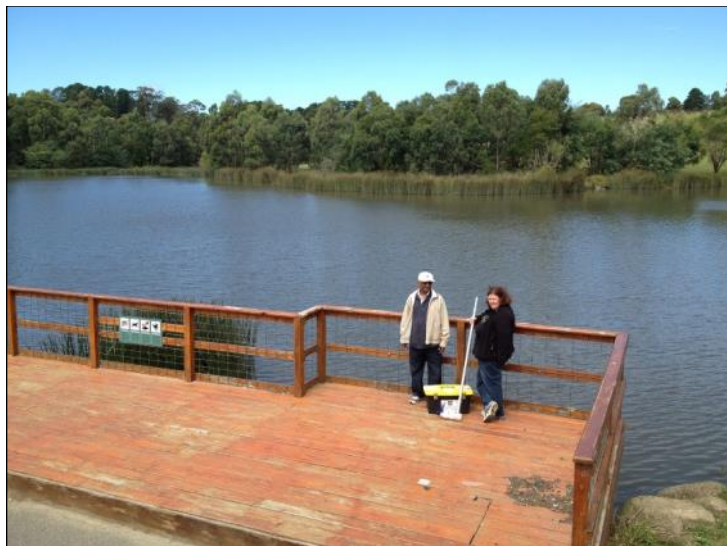
Ruffey Creek @ Ruffey Lake

2019 Results	A Excellent	B Good	C Fair	D Poor	E Degraded	F Very Degraded
Overall Rating			💧			
Ortho Phosphorus	💧					
Electrical Conductivity	💧					
Turbidity	💧					
pH			💧			
Ammonium			💧

Water Quality Rating	2007	2008	2009	2010	2011	2012	2013	2014	2015	2016	2017	2018
Overall Rating						C	C	C+	B-	C-	C-	C
Nutrient Rating												
Phosphorus						C+	A	C+	B+	B-	B	C
Ammonium (ANZECC guideline trigger value)												
% Pass						30	82	70	83	55	72	72
% Fail						70	18	30	17	45	28	28
Physio/chemical Rating												
Turbidity						C	D+	C+	C	D+	C+	C
Conductivity						C	C-	C	C+	C	B-	C
pH						D+	D+	B-	B	D+	D+	D-

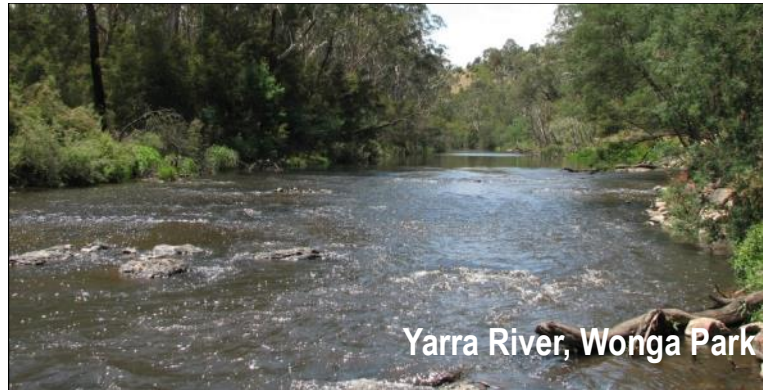
Yarra River, Wonga Park

The most likely cause of this increase in turbidity is the changing characteristic of the river between these two sites.

The river in Warrandyte is fast flowing with a rocky or gravel substrate. This compares with the river at Bulleen which is a slow flowing, deep, meandering flood plain with a muddy base.

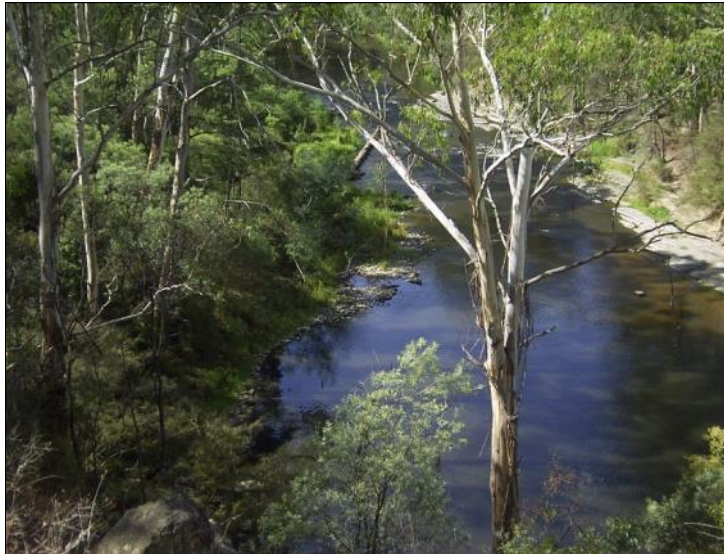
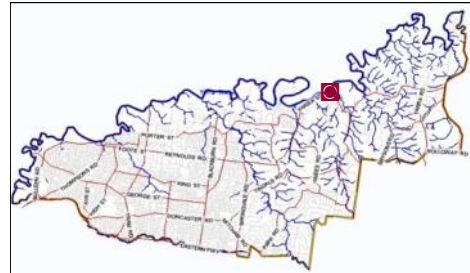
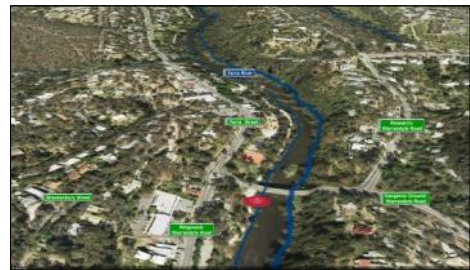
Yarra River @ Warrandyte Road Bridge

2019 Results	A Excellent	B Good	C Fair	D Poor	E Degraded	F Very Degraded
Overall Rating	[Green bar]		[Green bar with water drop icon]	[Light green bar]	[Yellow bar]	[Red bar]
Ortho Phosphorus	[Green bar]		[Green bar with water drop icon]	[Light green bar]	[Yellow bar]	[Red bar]
Electrical Conductivity	[Green bar]		[Green bar with water drop icon]	[Light green bar]	[Yellow bar]	[Red bar]
Turbidity	[Green bar]		[Green bar with water drop icon]	[Light green bar]	[Yellow bar]	[Red bar]
pH	[Green bar]		[Light green bar]	[Yellow bar]	[Red bar]	[Red bar]
Ammonium	[Green bar]		[Green bar with water drop icon]	[Light green bar]	[Yellow bar]	[Red bar]

Water Quality Rating	2007	2008	2009	2010	2011	2012	2013	2014	2015	2016	2017	2018
Overall Rating		B	B-	B-	C+	C	C+	B+	B+	B-	B	B
Nutrient Rating												
Phosphorus		B-	C	C+	C	C+	C	A	A-	B	B	B
Ammonium (ANZECC guideline trigger value)												
% Pass		100	60	92	100	90	80	100	100	100	90	100
% Fail		0	40	8	0	10	20	0	0	0	10	0
Physio/chemical Rating												
Turbidity		A+	C	B-	B-	C+	C	B	B+	C	B	B
Conductivity		B	B	B	B	B	B	B	B	B	B	B
pH		B	B	B	B-	C+						B
